**From:** tg lining bv [info@tglining.nl]  
**Sent:** Tuesday, October 10, 2006 6:20 AM  
**To:** Chandler, Mark  
**Subject:** FW: text by photos tg lining

*Inside public buildings*

### Stairs

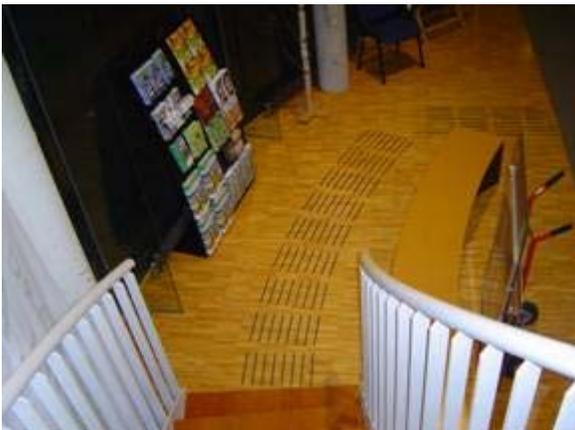
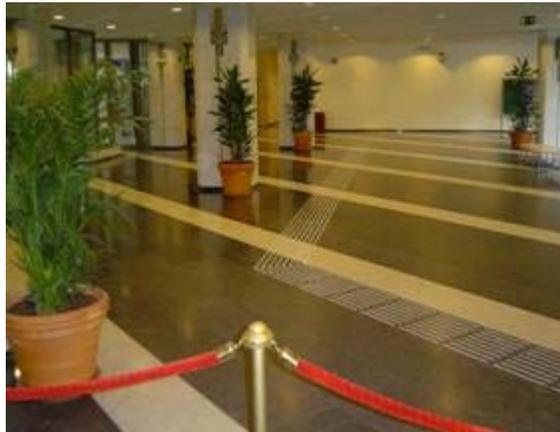
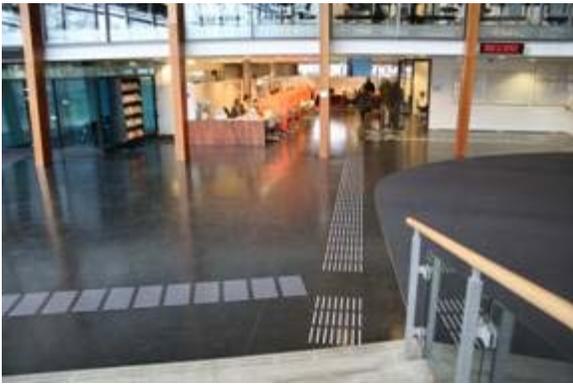
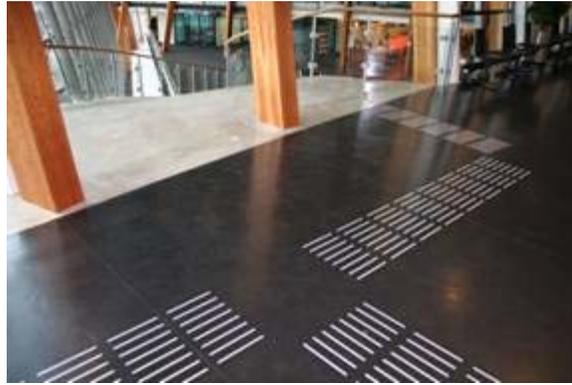
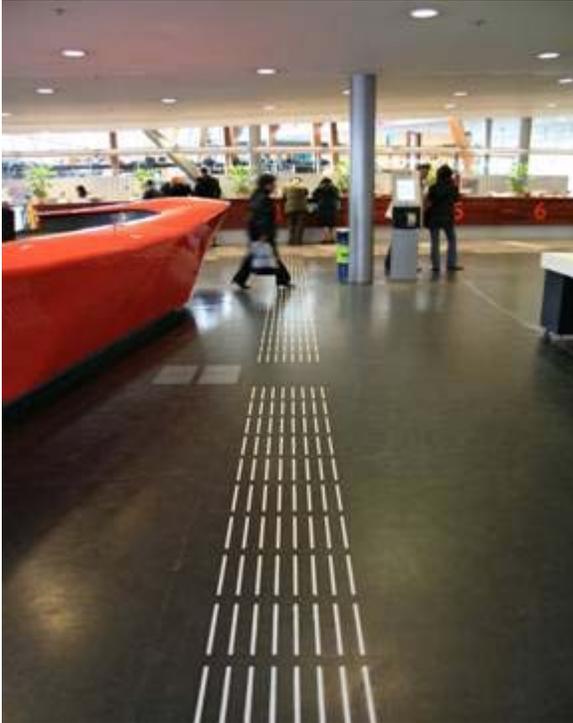
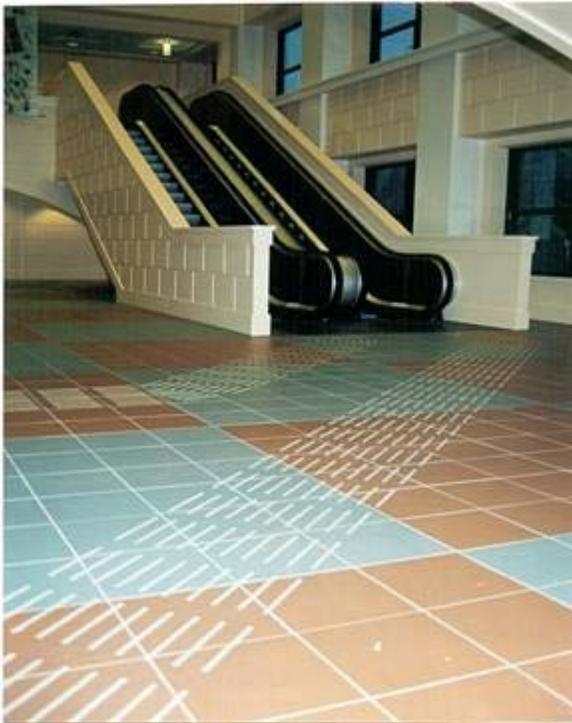
Guide paths inside public buildings are connected to the guide paths outside. By echo noises inside halls etc. it is extremely difficult to find your way. Often inside guide path become used by non-visually impaired too. As non-skid track during cleaning, as safety line in case of fire, to find your way to a particular place, etc. Some pictures of town halls, EU Governmental buildings Brussels, Ministry of Health Den Hague, hospitals, etc.

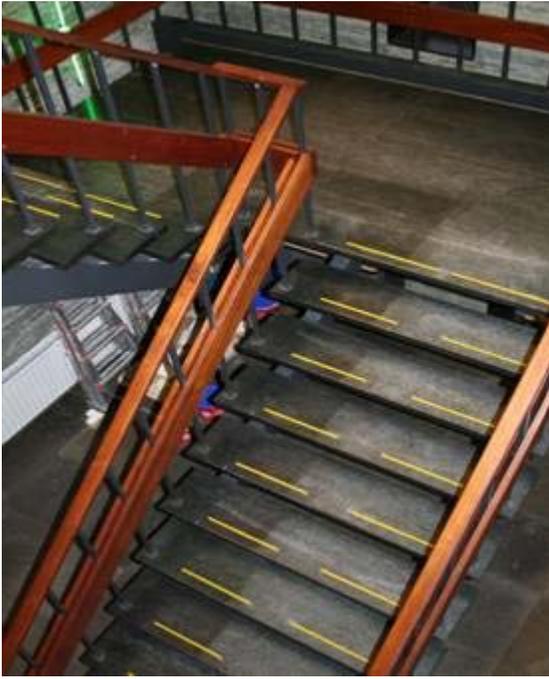
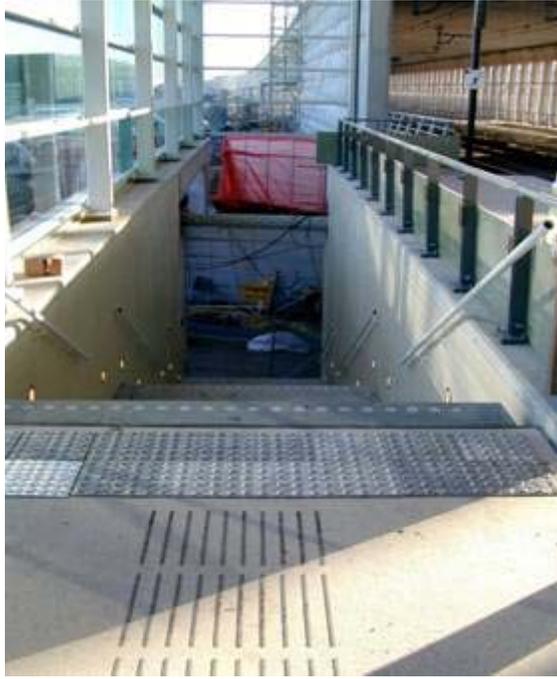
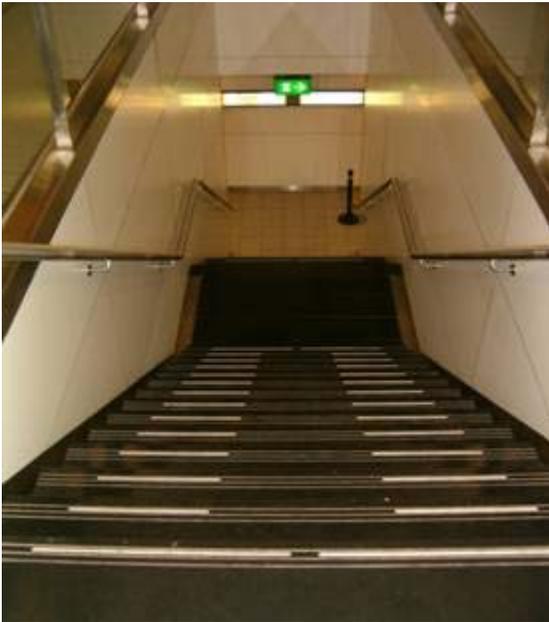
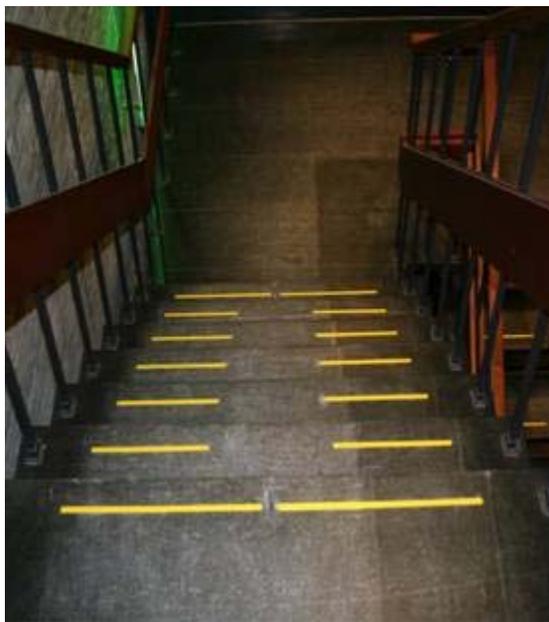
Accidents happen mainly if you estimate the steep of a stair in the wrong way. With reading parts in your glasses you do not see the stair in focus from top of the stair looking downwards. Short contrast coloured ridges left and right on the steps give much better three dimensional information than ridges on the complete length of the step.

Visually impaired estimate the steepness by hand nearly one footstep in advance if the banister starts horizontally before the first upper step. If the banister is not present in the right way you need extra warnings by sound tile in stations. Some pictures of Airport Amsterdam, Van Gogh Museum, Ministry of Education, Ministry of Health, Railways station.
